ABBREVIATED PRELIMINARY ASSESSMENT

CAP MARTIN COMPLEX

Wallowa-Whitman National Forest
Grant County, OR

August 2006

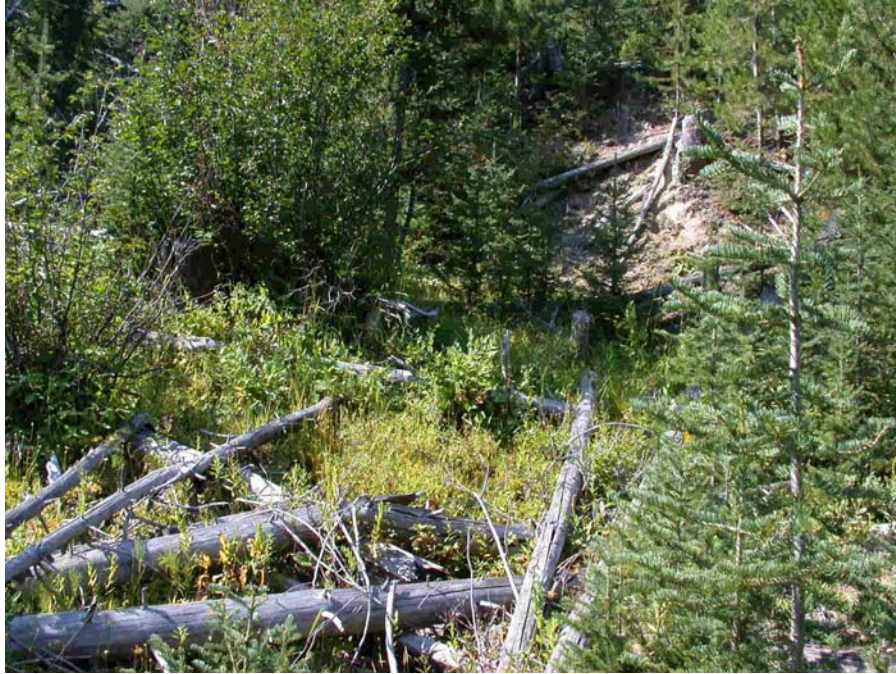
- Adit #1
 - Water discharge from collapsed adit.
 - Visually, does not appear impacted.
 - Marshy area between mine and Granite Creek.

- No signs of distressed vegetation.
 - Water in this area does drain to Granite Creek.
 - Wasterock material could not be located.
 - Either it is within the marshy area, or

Photo 1. Location of Adit #1. (Photo by D. Boles)

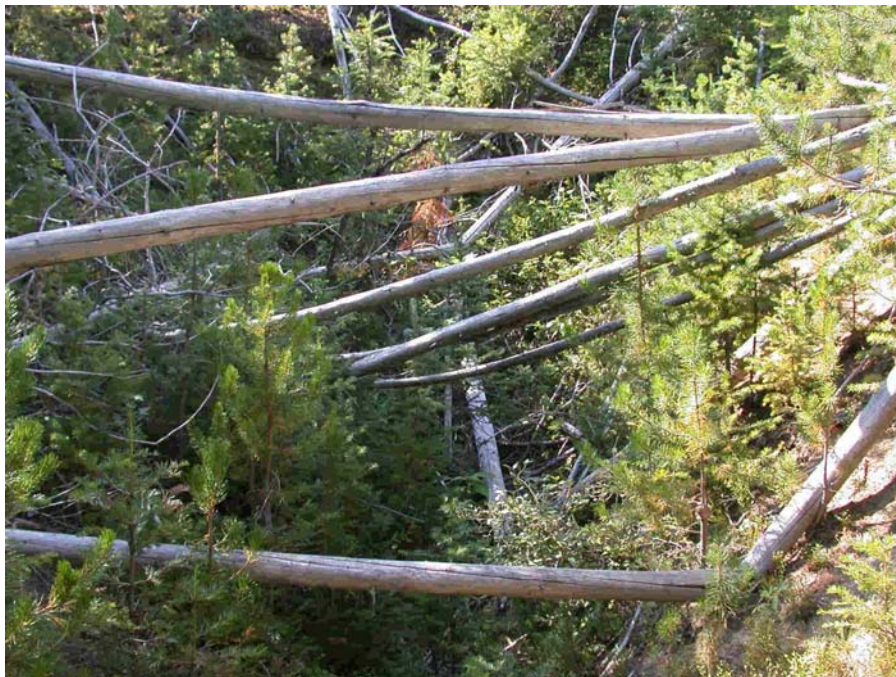
- Part of a logging road that was built post mining operations.
- Adit #2
 - No water discharge from the adit.
 - Marshy area associated with Adit #1 reaches the toe of the wasterock pile on the north side and then drains into Granite Creek

Photo 2. Location of Adit #2. (Photo by D. Boles)

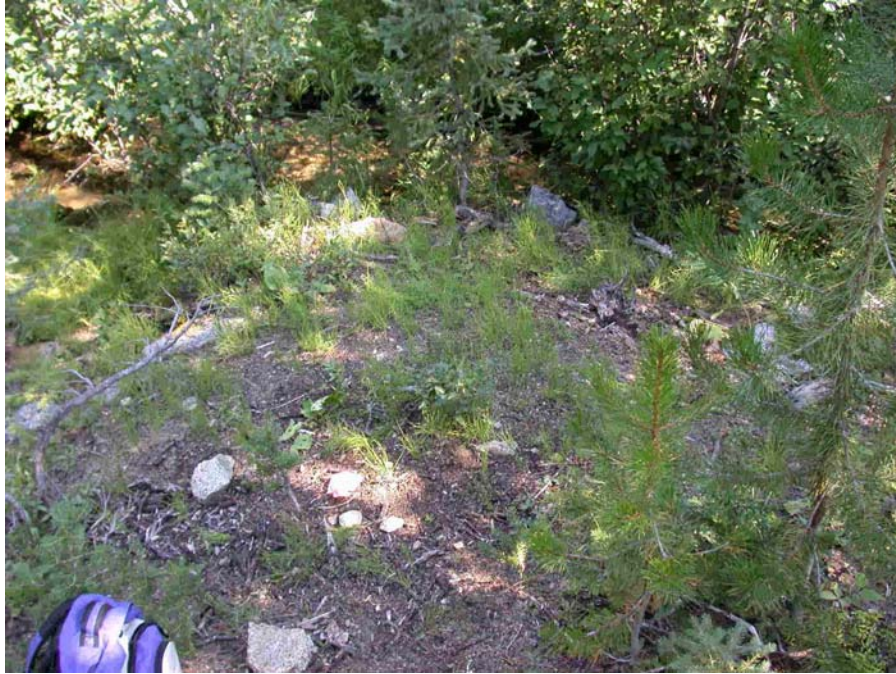
- Approximately 500cy of wasterock.
 - Wasterock extends to the edge of Granite Creek.
- Adit #3
 - Large collapsed adit.
 - Volume of wasterock in the area difficult to determine because of the amount of disturbance. As an approximation – 6000cy.

Photo 3. Wasterock at Adit #2 extending to edge of Granite Creek.
(Photo by D. Boles)

Nickel 93.6	Plants 30.0	Industrial 20,000
	Selenium 3.6	Plants 1.0	Industrial 5,100
	Zinc 50.7	Plants 50.0	Industrial 100,000
Sample #3 Wasterock by Adit #2	Arsenic 105.6	Plants 8.0	Industrial 1.6
	Chromium 74.8	Invertebrates 0.4	Industrial 450
	Copper 8.25	Invertebrates 50.0	Industrial 41,000
	Iron 24,297	Plants 10.0	Industrial 100,000
	Lead 24.51	Birds 16.0	Industrial 750
	Manganese 441	Invertebrates 100.0	Industrial 19,000
	Mercury 2.54	Invertebrates 0.1	Industrial 310
	Nickel 39.8	Plants 30.0	Industrial 20,000
	Zinc 67.7	Plants 50.0	Industrial 100,000

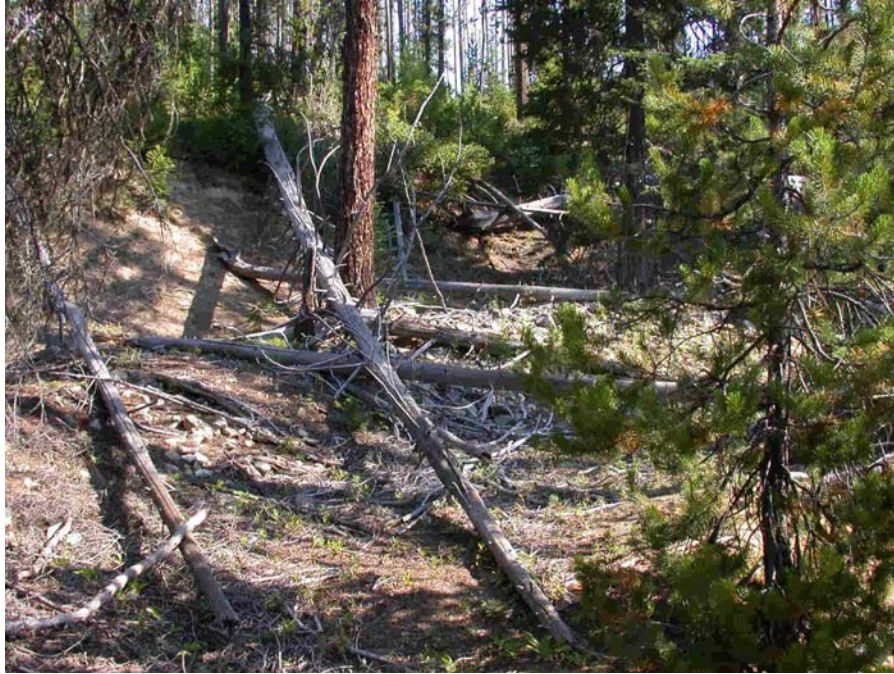
- A large pit exists. Upon closer examination, appears to be a collapsed shaft.
 - A drift or crosscut extends from the area of the shaft. See Photo 6, Appendix C.

Photo 5. Large pit. Appears to have been a shaft with a drift or crosscut, See Photo 6. (Photo by D. Boles)

SAMPLE LOCATION	TEST RESULTS Element mg/kg	STATE GUIDELINES Receptor mg/kg	EPA Standard mg/kg
Sample #1 Wasterock by Adit #4 shaft	Arsenic 100.6	Plants 8.0	Industrial 1.6
	Chromium 30.9	Invertebrates 0.4	Industrial 450
	Copper 7.56	Invertebrates 50.0	Industrial 41,000
	Iron 13,802	Plants 10.0	Industrial 100,000
	Lead 10.16	Birds 16.0	Industrial 750
	Manganese 36.6	Invertebrates 100.0	Industrial 19,000
	Mercury 5.89	Invertebrates 0.1	Industrial 310
	Nickel 20.7	Plants 30.0	Industrial 20,000
	Selenium 0.81	Plants 1.0	Industrial 5,100
	Zinc 45	Plants 50.0	Industrial 100,000
Sample #2 Wasterock in area of Adit #4	Arsenic 60	Plants 8.0	Industrial 1.6
	Chromium 7.75	Invertebrates 0.4	Industrial 450
	Copper 3.98	Invertebrates 50.0	Industrial 41,000
	Iron 32,308	Plants 10.0	Industrial 100,000
	Lead 10.66	Birds 16.0	Industrial 750
	Manganese 837	Invertebrates 100.0	Industrial 19,000
	Mercury 3.6	Invertebrates 0.1	Industrial 310

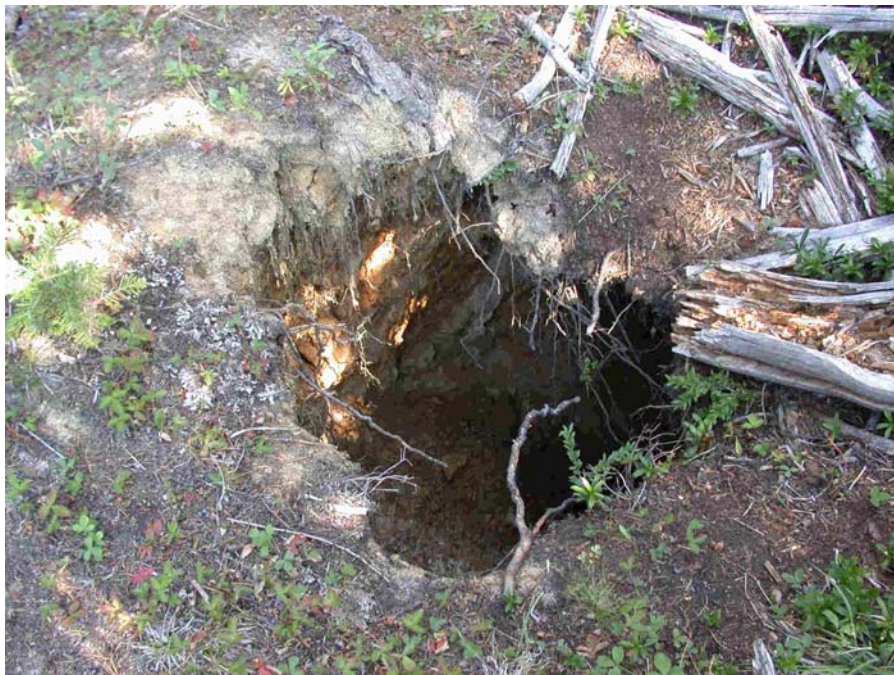
Photo 6. About a 3' diameter hole leading to what appears to be a drift or crosscut coming from the possible shaft as shown in Photo 5. (Photo by D. Boles)

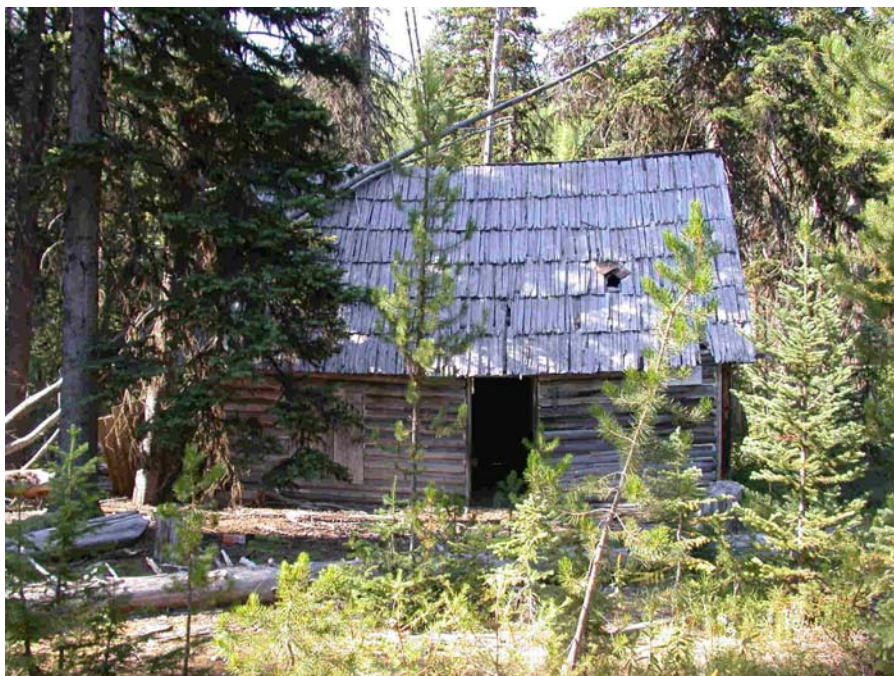
Photo 7. Backside of log cabin as shown on the cover page. (Photo by D. Boles)

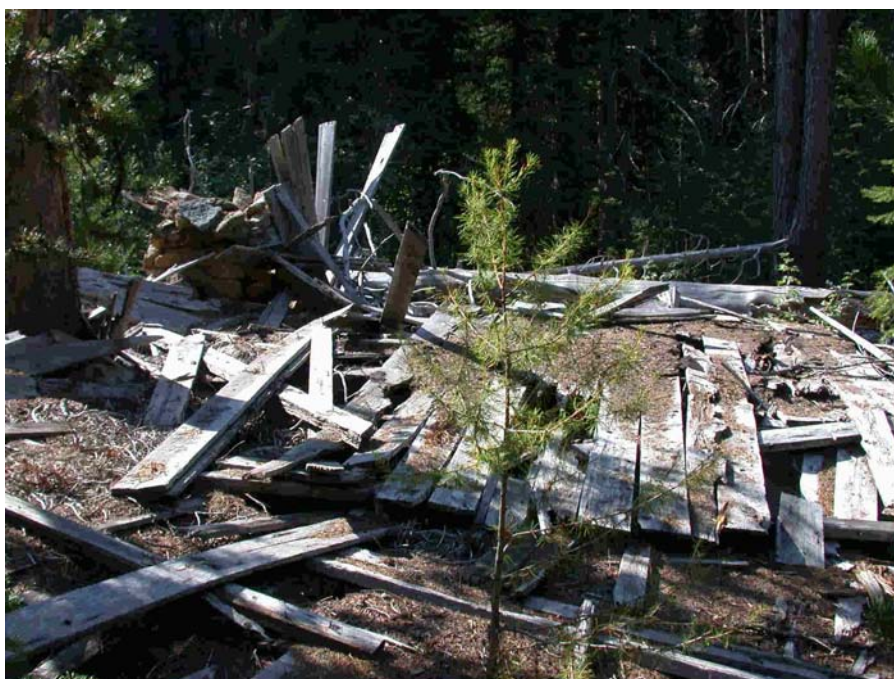
Photo 8. Remains of possible cabin. (Photo by D. Boles)
